PROFESSIONAL ENGINEERS PLAN

*Underground Process Wastewater Line
Inspection
&
North Plateau Contaminated Groundwater Line
Integrity*

Prepared For:
West Valley Demonstration Project
10282 Rock Springs Road,
West Valley, NY 14171

Project #03027

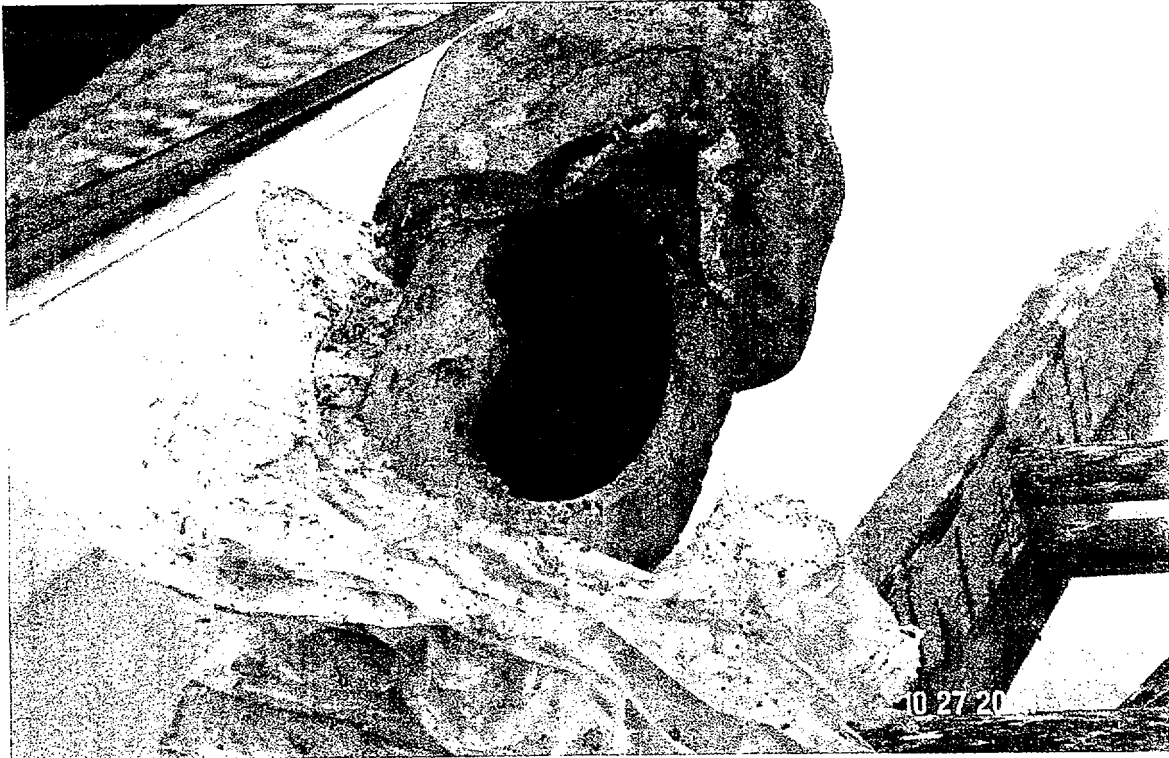
Photo # 1 Breach "L"

Entry Point "L" - Upon trying to access through point "L", a blockage was encountered in the clean-out riser section. After excavation a puncture hole in an elbow section of the pipe between two fittings in the clean-out riser was found. As indicated by Photos No. 1 & 2 provided in Appendix B, this break appears to be not related to the pipe function or serviceability but rather damage caused during original installation of the pipe or subsequent nearby construction operations, Photo No. 3 shows the extent of the clog in clean-out riser "L", as well as, an indication of the pipes cross-section.. The broken section of pipe was removed and access gained for the camera. The piece was replaced with a new clean-out riser section as shown in Photo No. 4, provided in Appendix "B".

Structurally, a breach in clean-out riser section "L" was discovered and apparent longitudinal cracking in the clean-out riser at "E" was also identified. The breach at "L" appears to be construction-related and not operation or service-related. The longitudinal cracking at "E" may be due to either frost action or work activities in the area and does not seem to be compromising the system integrity as long as the system is properly maintained and does not surcharge. Since the breach at "L" was receiving the laundry waste stream and was not evident until video surveys were performed, it is recommended that other lines (e.g. clean-out risers and laterals) that convey process wastewater flow, that have not already been surveyed, should be surveyed.

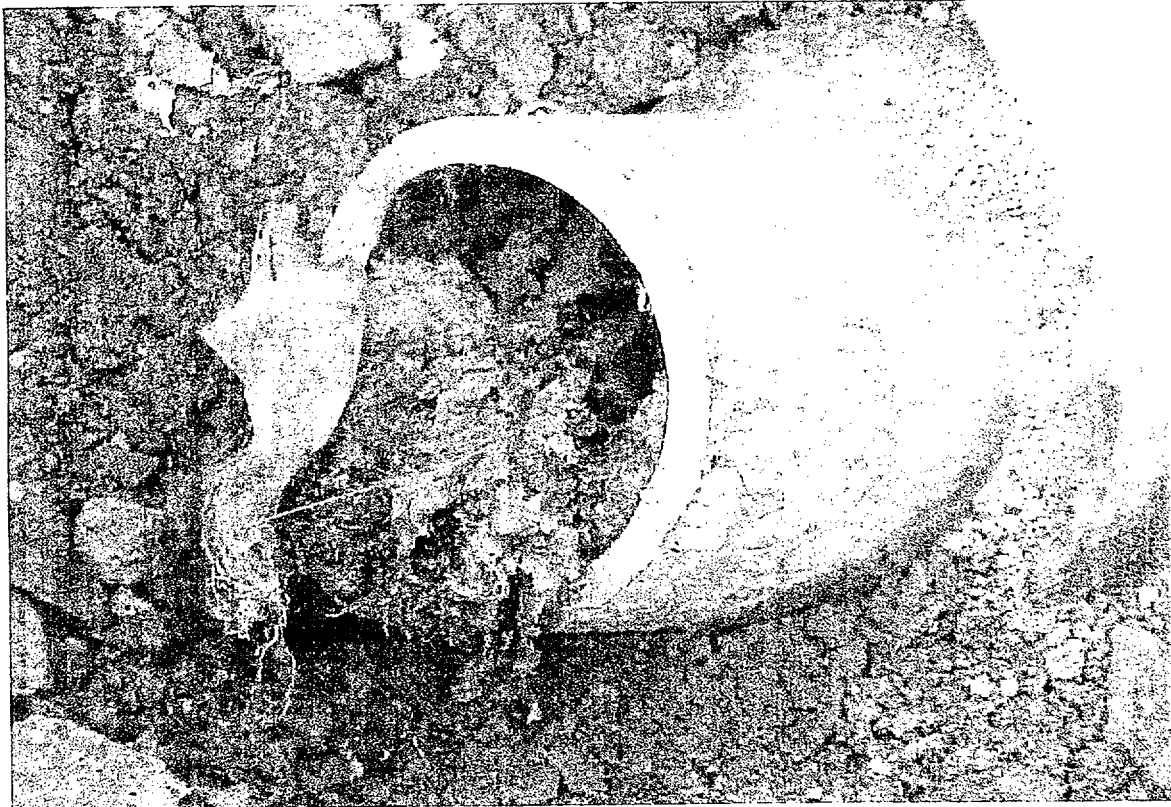
Photo #3 Clog at "L"

The first attempts into entry point "L" on 10/14/03 failed due to a blockage in the clean-out riser. From the video recordings, it was not clear whether the pipe was clogged or there was a breach of the pipe. Operations were then undertaken to expose the pipe and fix the clog and, or breach. After exposing the section of pipe, it was confirmed that the section of pipe in the clean-out riser had a puncture hole at an elbow. The recordings, at entry "L", were made after the clean-out riser section was exposed and the broken section of pipe removed and, before replacing the clean-out riser section.
